Dominica

Landslides and floods triggered by Hurricane Maria (18 September, 2017)

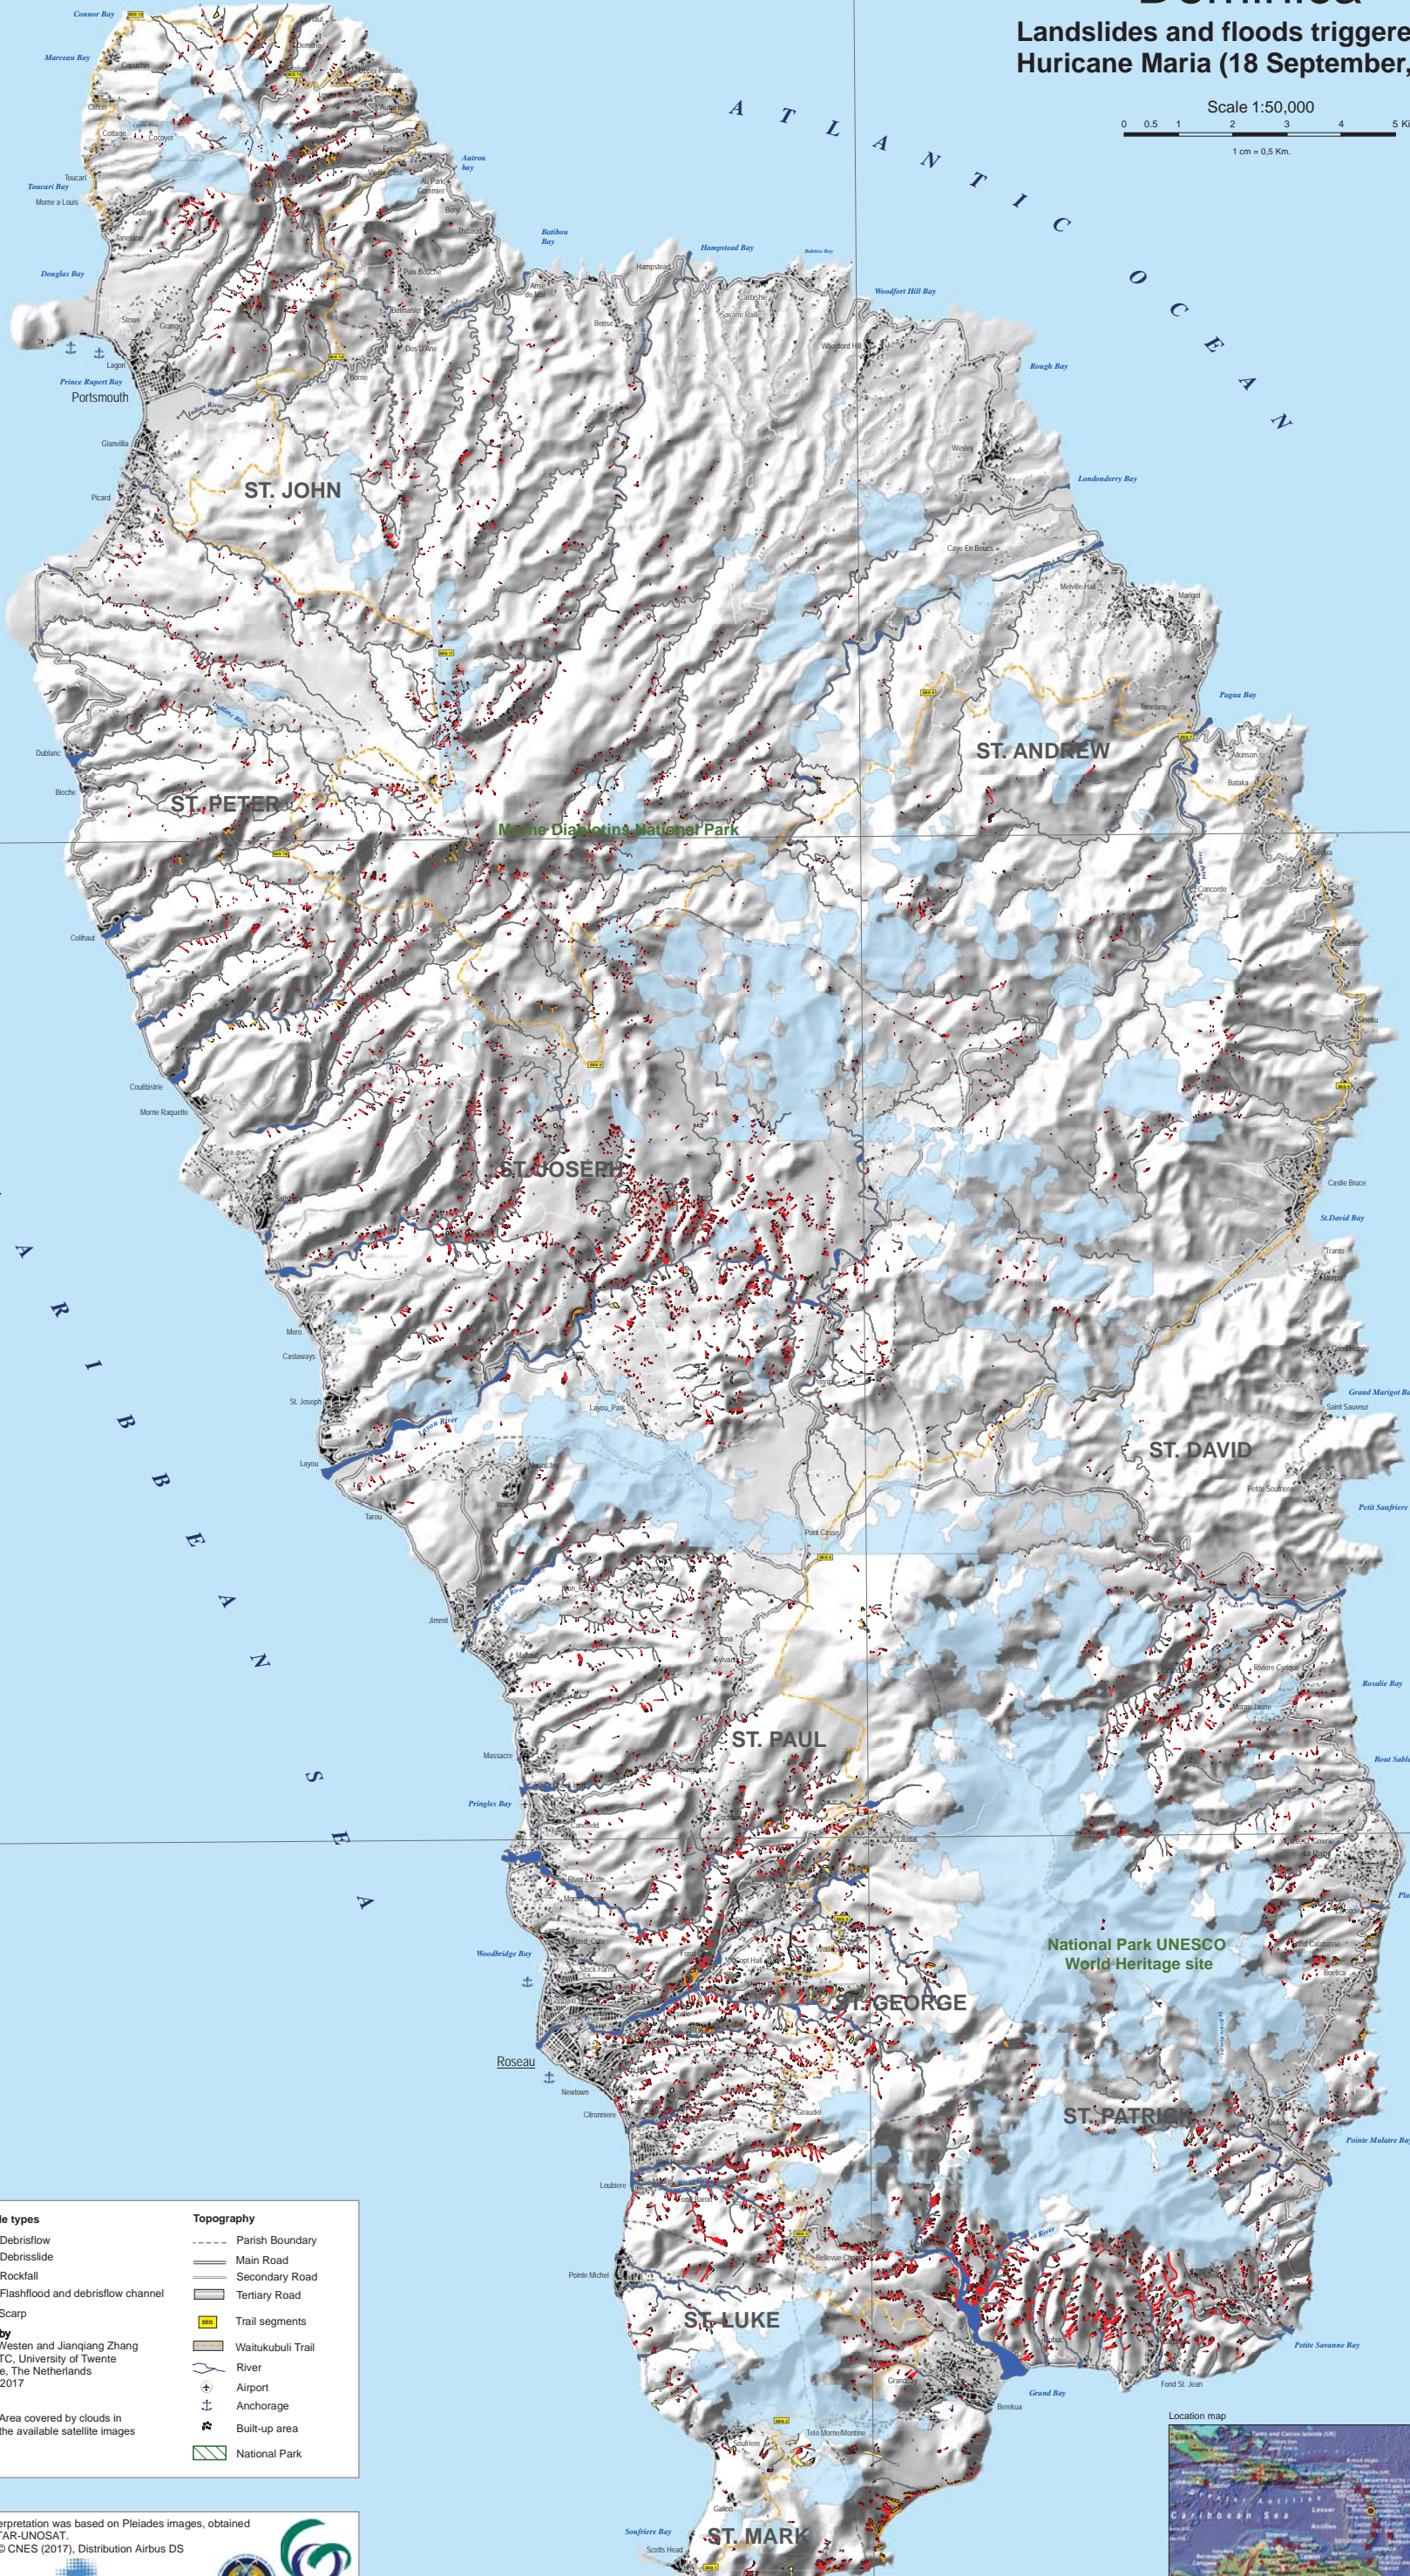
Area covered by clouds in the available satellite images

Image interpretation was based on Pleiades images, obtained from UNITAR-UNOSAT.
Pleiades © CNES (2017), Distribution Airbus DS
